**Docket No. 217 – Development and Management Plan Inspection**

Northeast Utilities Service Company Certificate of Environmental Compatibility and Public Need for the construction of a 345-kV electric transmission line and reconstruction of an existing 115-kV electric transmission line between Connecticut Light and Power Company's Plumtree Substation in Bethel, through the towns of Redding, Weston, and Wilton, and to the Norwalk Substation in Norwalk, Connecticut.

**Date:** July 28, 2005

**Location:** 345 kV Underground Route

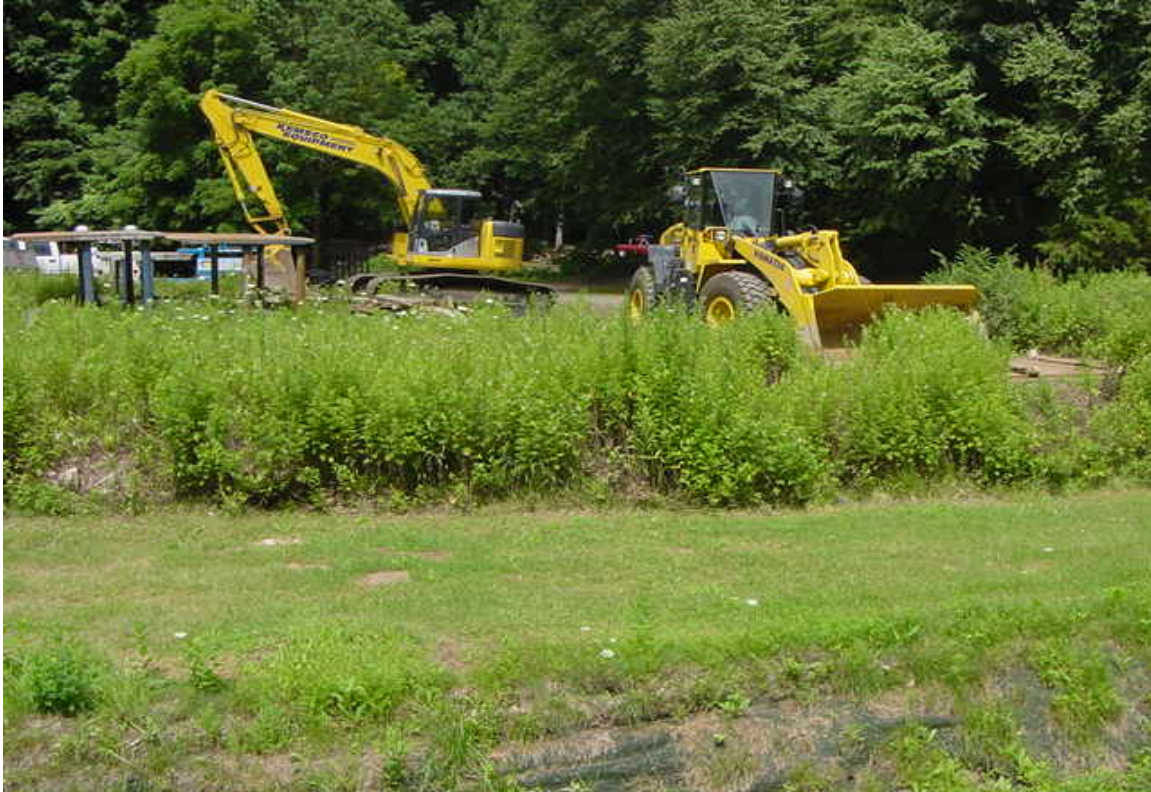
345kV (Rt. 7 Wilton) View of the storage area off Route 7. All equipment is stored appropriately (7/28/05)

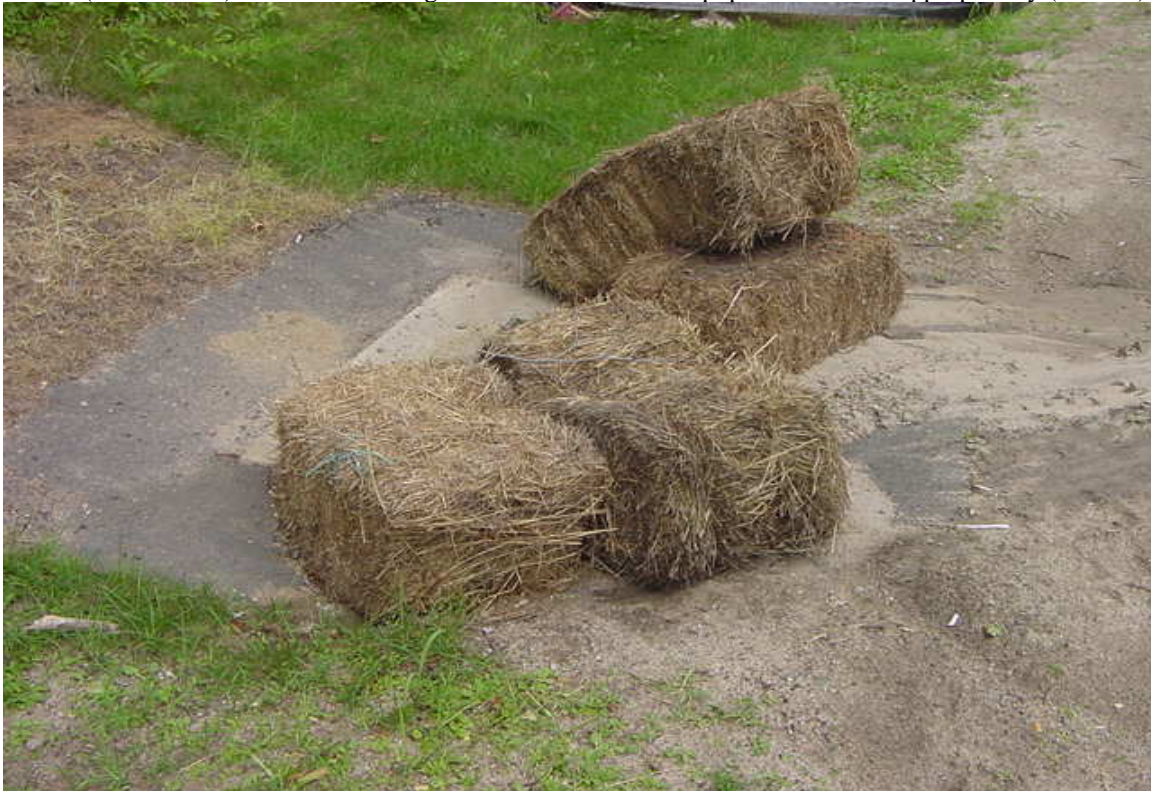
View of a catch basin along Rt. 7 which has been placed with haybales. The bales should be placed in a box or border shape around the inlet. (7/28/05)

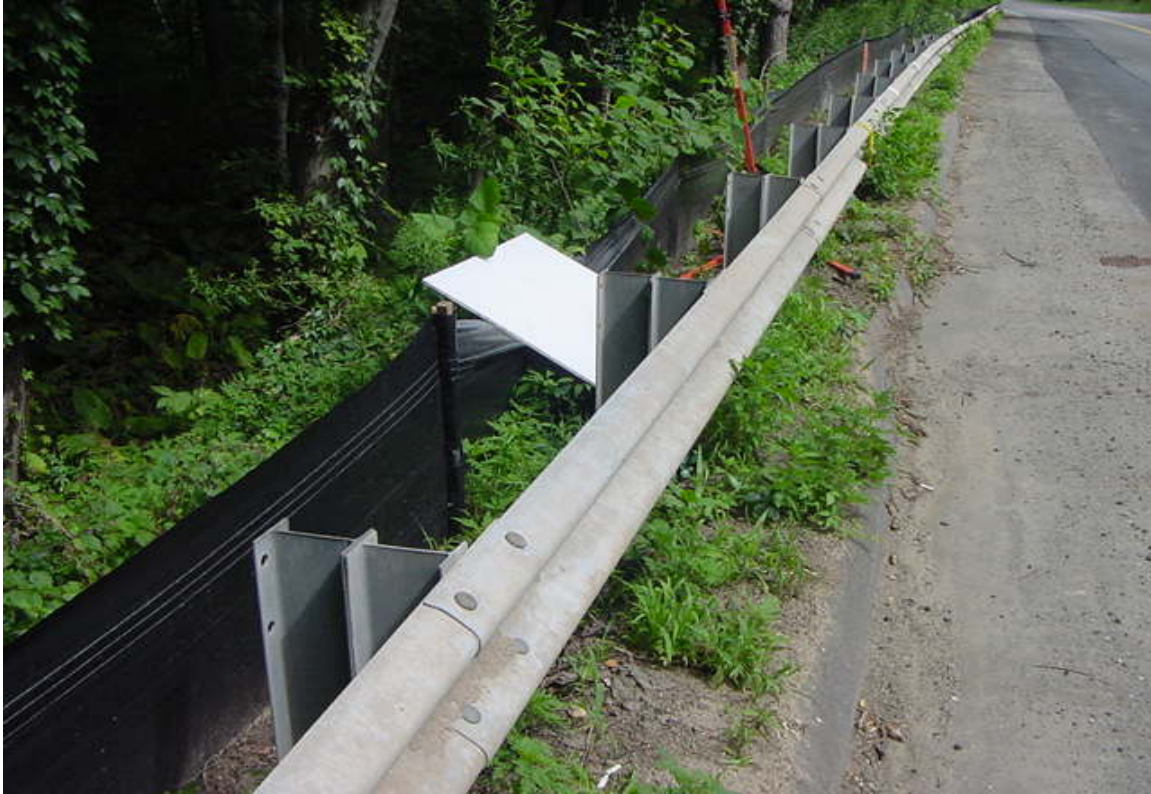
View of silt fence well installed along Rt. 7. Take care not to place materials on or against the fence  
(7/28/05)
